## La Bohème Recent Work

### Recent work

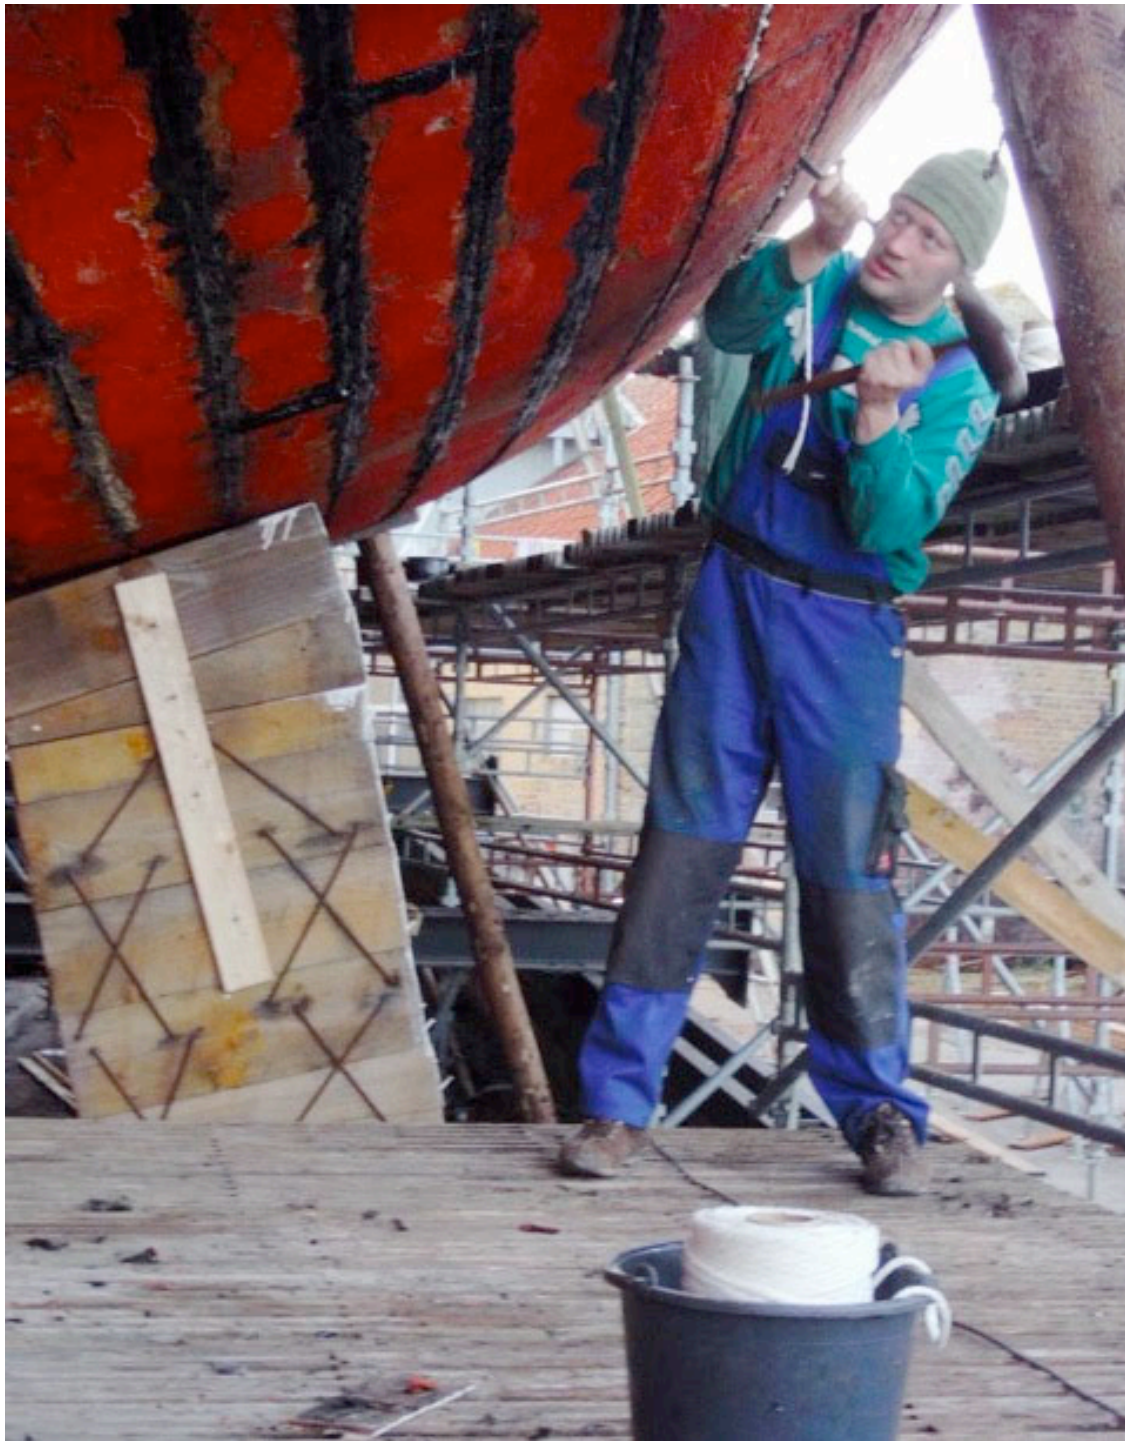
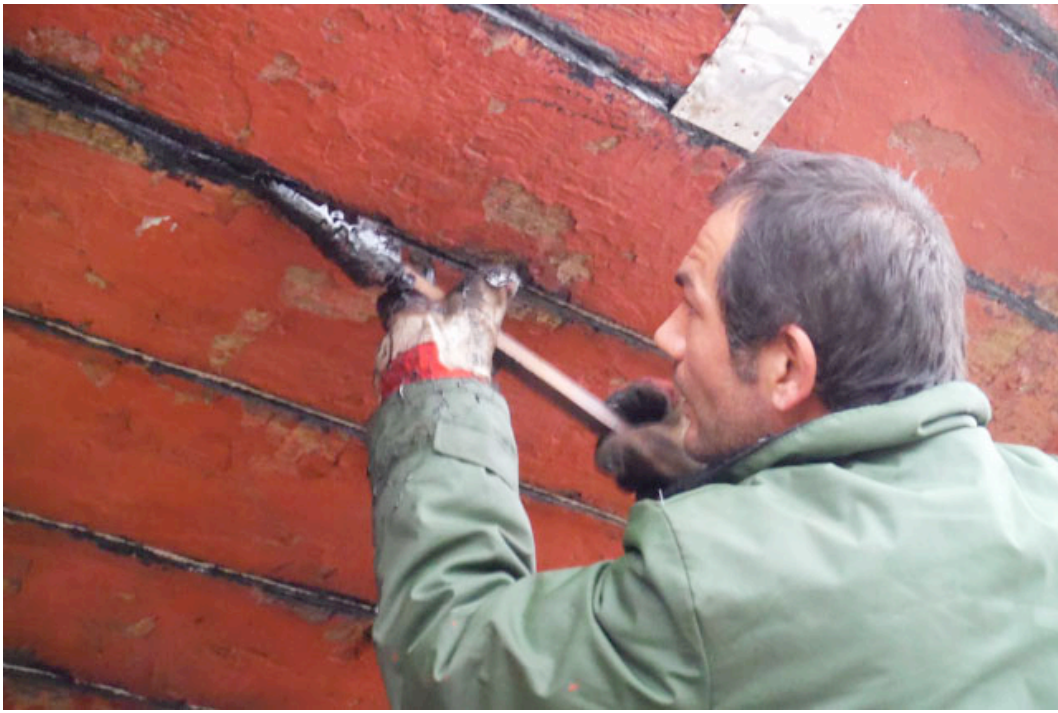
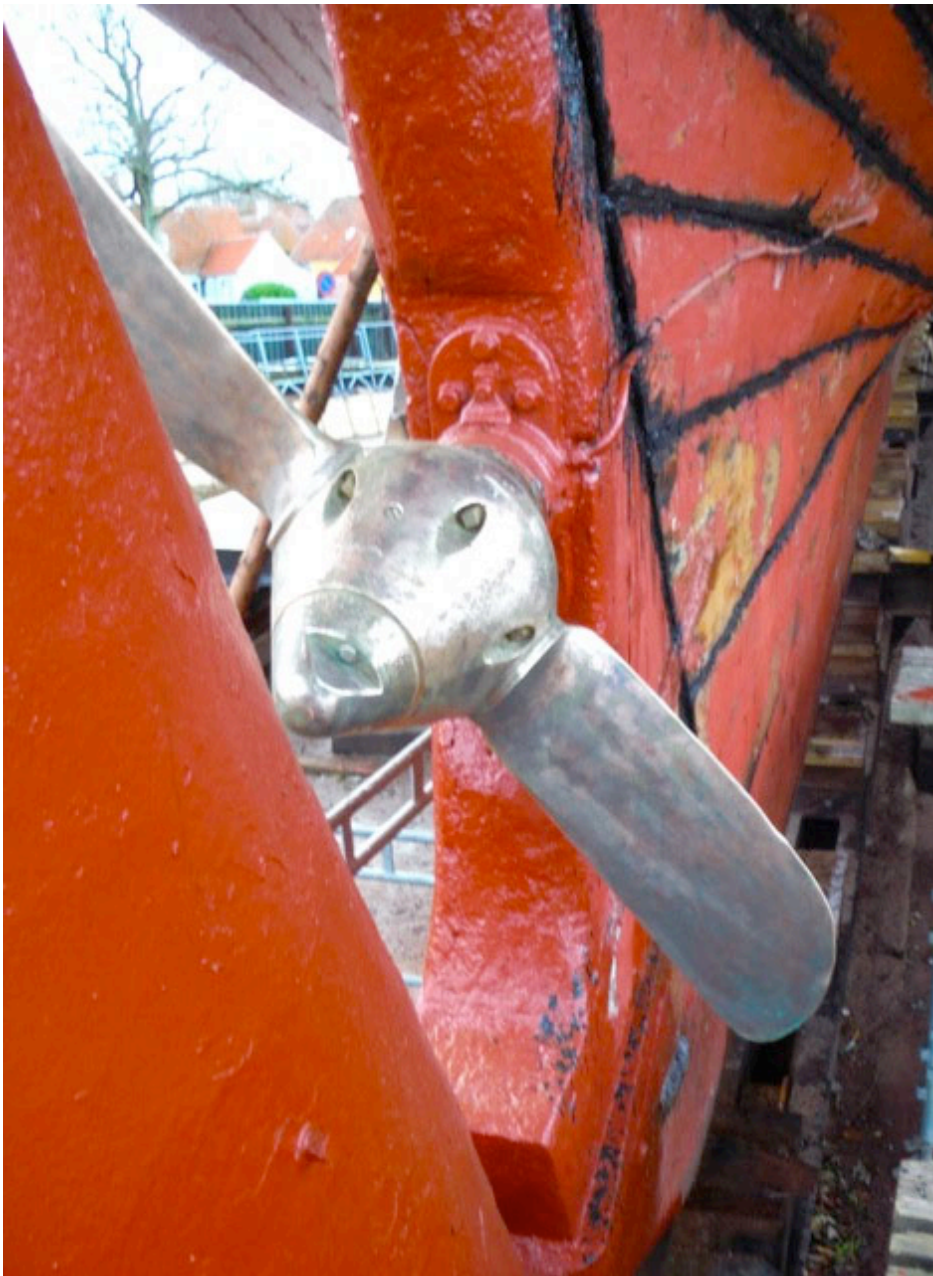
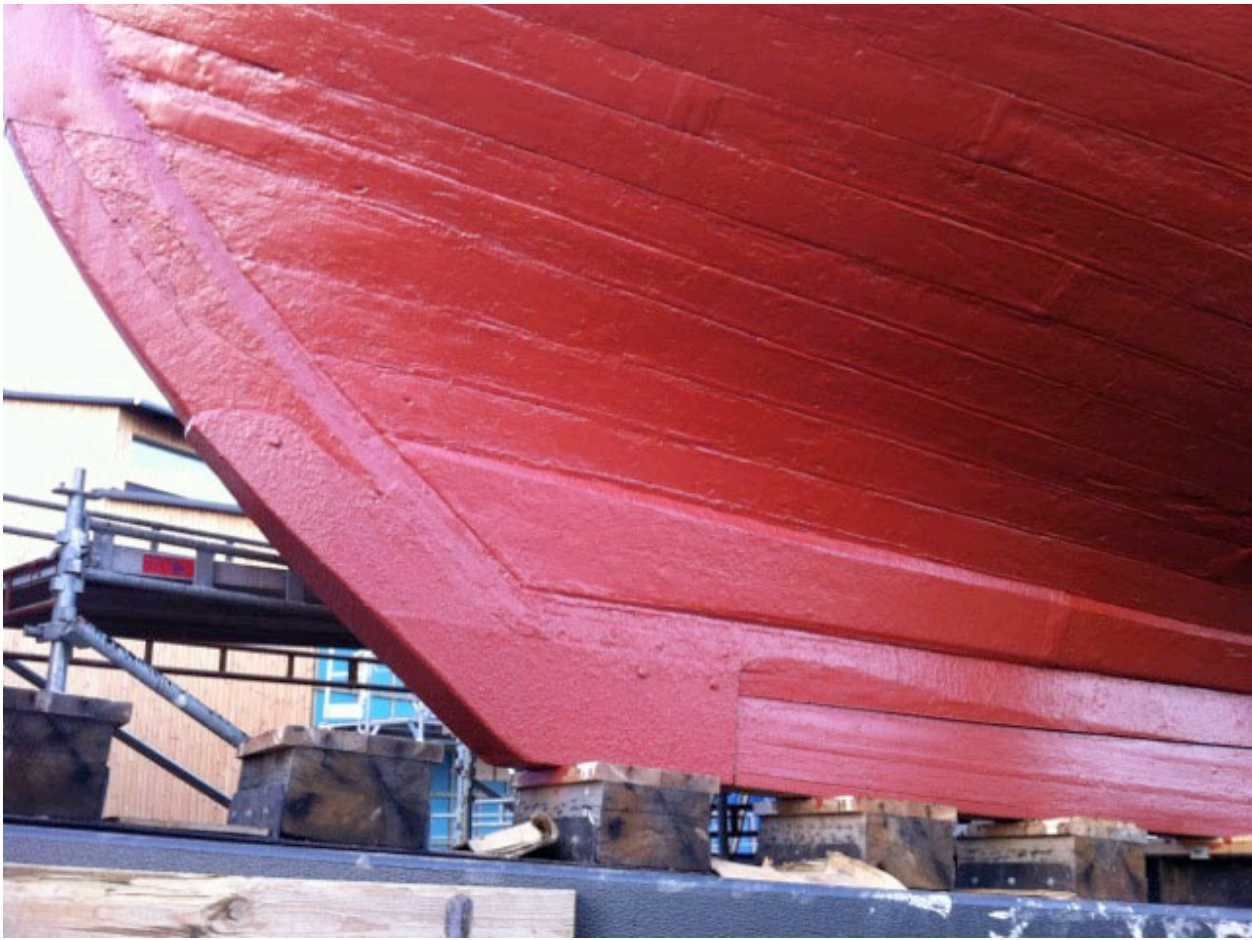
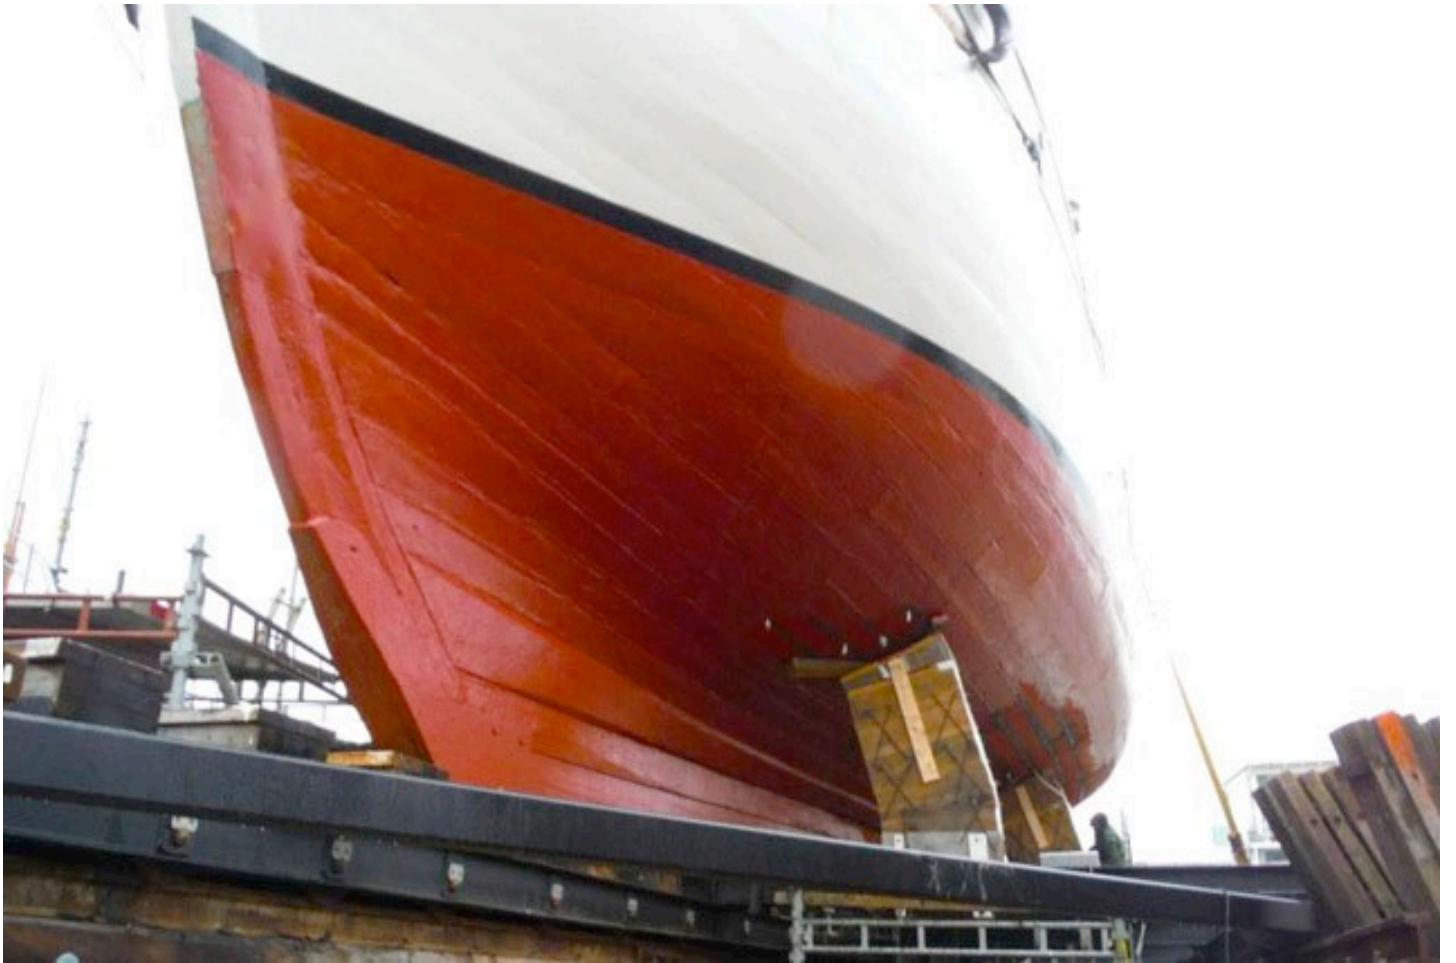
Some photos of the two months of work:

In keeping with the extensive restoration work carried out by the previous owner over the last 20 or more years, the new owner undertook the final major work - complete re-caulking - in the Autumn of 2013. The vessel was slipped in southern Denmark and surveyed, prior to the work being carried out by a team of professional shipwrights. In all, 700m of seams were fully re-caulked. This involved six processes for each seam. All underwater hull and many topsides seams were sealed, meaning a total of 4.2 km of seam work. To doubly ensure the length of service the caulking should give, care was taken to apply tingles over vertical plank end seams (from the unique old Swedish construction method), and over old engine mount bolt heads. Two coats of high quality anti-foul were laid on.
